BENTON LAKE NATIONAL WILDLIFE REFUGE

ANNUAL NARRATIVE REPORT

Calendar Year 1985

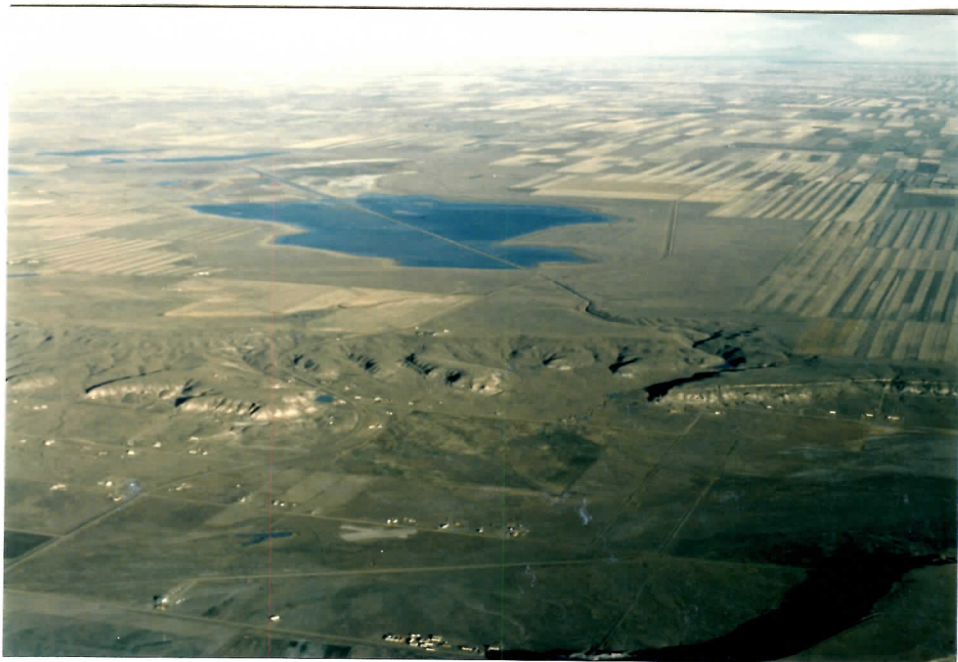
The natural outlet from Benton Lake where it passes through Rattlesnake Ridge and spreads out onto Black Horse Lake flats before travelling some 15 miles down Blackfeet and Portage Coulees to the Missouri River. Original and recurrent plans call for the development of a gravity drain system out of Benton Lake to the Missouri River.

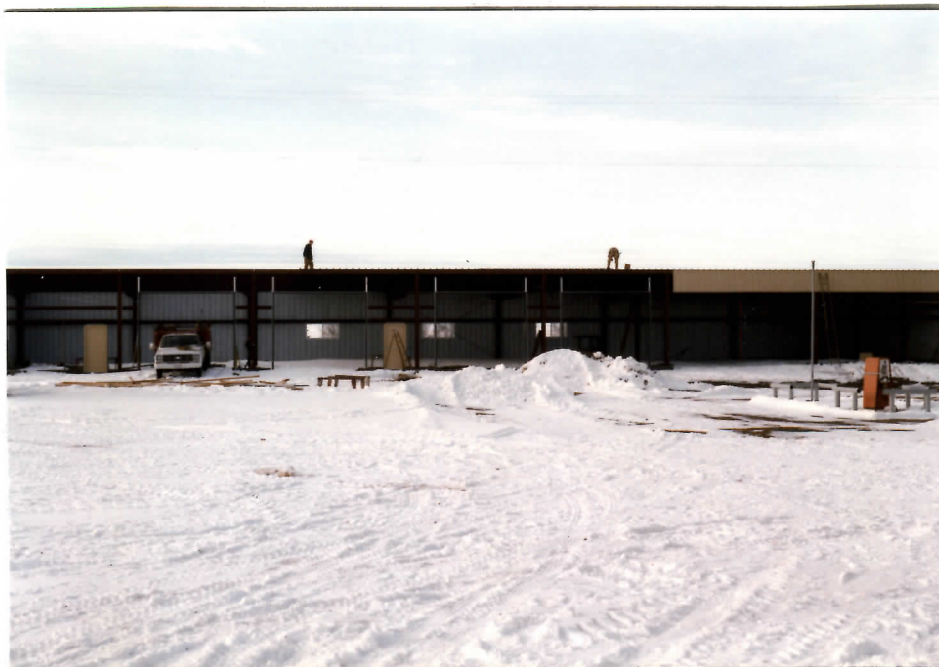
Roof sheeting going on. Windows and walk in door are in place. One bundle of sheeting, left on the ground, got damaged following a heavy snow storm when snow removal operations began.

In December Maintenceman Vince Marko accidentally damaged a bundle of galvalume siding for the new storage building during snow removal operations. The refuge replaced the damaged bundle.

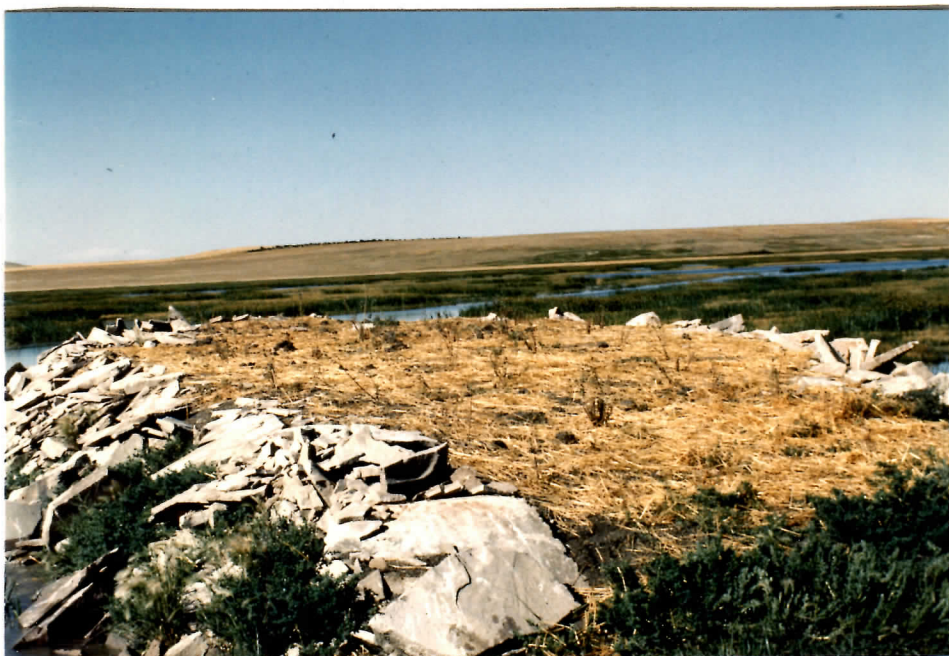
Buck brush (snowberry) and wild rose were transplanted onto three of the eight nesting islands in Unit VI by our YCC crew. Now if the wind doesn't blow it all away - and - and 08/02/85 Personal Photo D0

Wetland habitat improvement work this year included a YCC project on three of the recently built islands in Unit VI. Buck brush and wild rose were transplanted onto these islands; tall wheatgrass and yellow sweet clover seed were hand broadcast onto the intervening areas then mulched with straw and irrigated a couple of times. We want to get a good nesting cover established on these islands which will also reduce use by California gulls. See Section I-1 for other wetland habitat improvements.

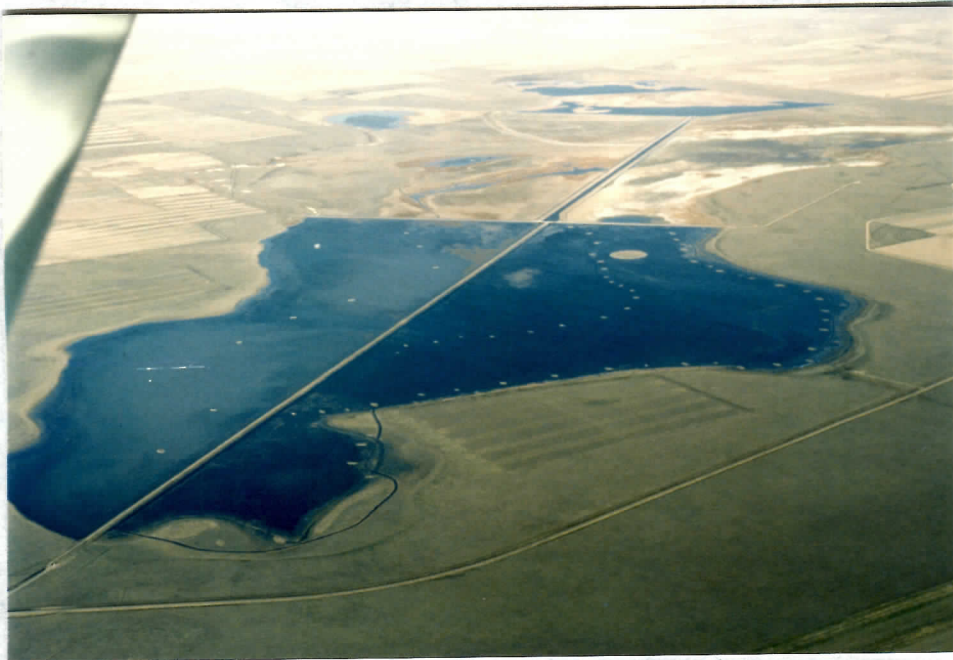
Unit V following reflooding this fall. A perimeter and an interior canal were excavated - spoil was used to develop 66 loafing islands near the canals. Peninsula cutoff islands were formed in the lower left bay. A four acre circle dike excludes water in a portion of the upper end of the unit - simulating an island.

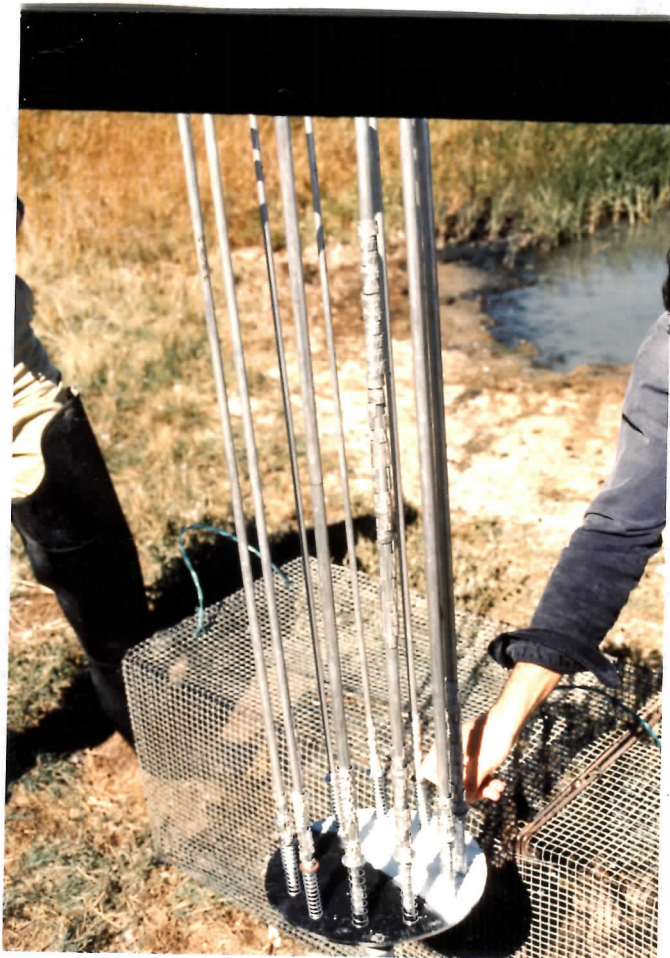
A banding carousel using aluminum rods was constructed by Dennis Orthmeyer. This did much to facilitate record keeping during the duck banding operation.

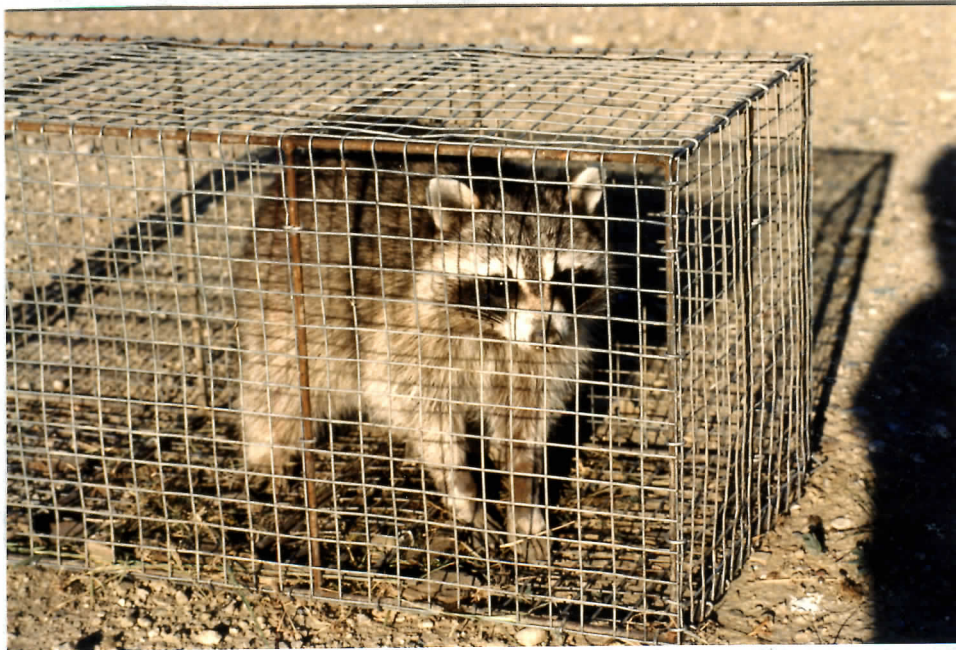
The duck trapping operations were protected from raccoons by the use of live traps.

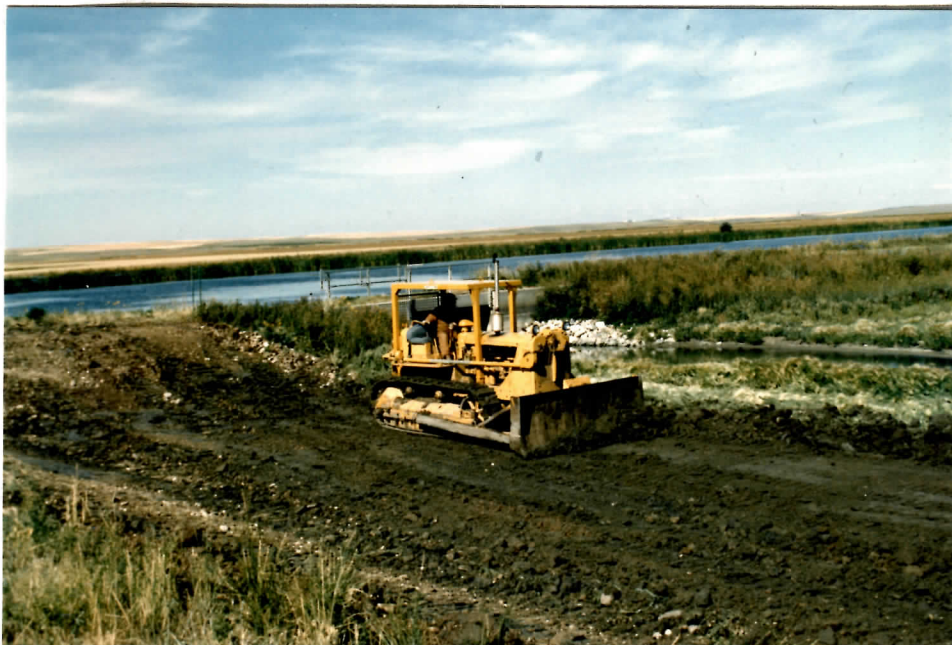
Cat begins excavation for the Unit III pumpsite near the southeast end of the main distribution canal.

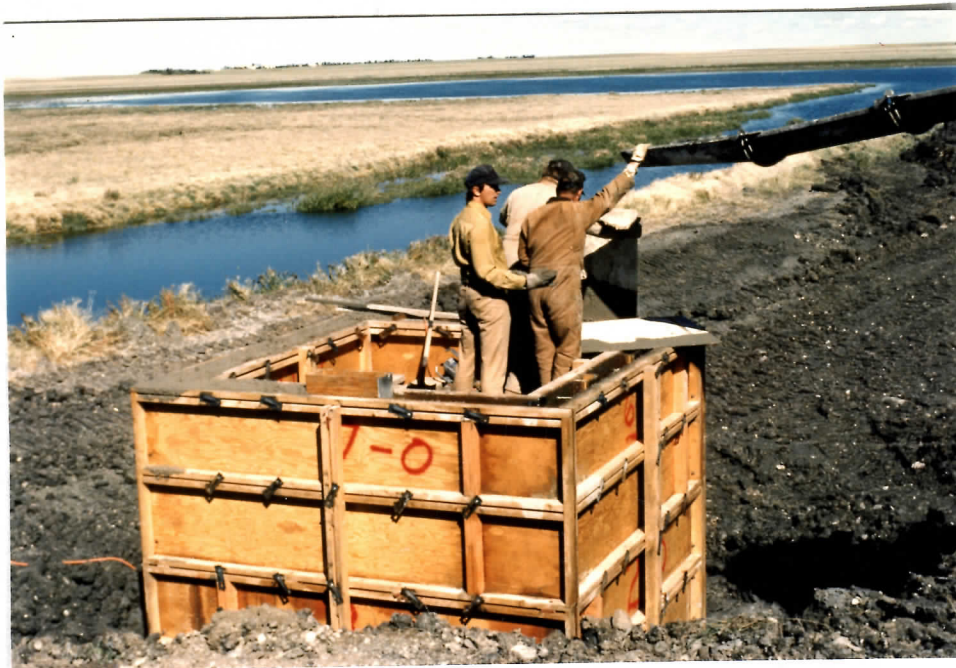
Mark Lanier, Bio Tech, and Maintenance men Vince Marko and Scott Foster receiving the last "mud" for the top 8 foot section of the Unit III pumpsite.
09/25/85 85-12-11 RLP

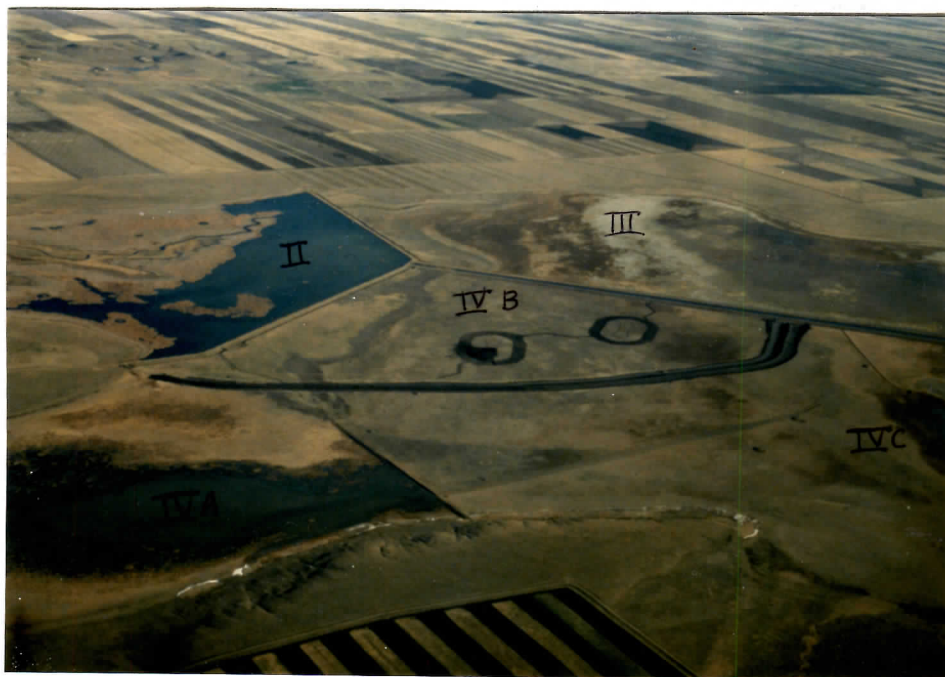
Aerial view of Ducks Unlimited project showing the relationship to other marsh units. Dirt work was nearly completed on the IVb dike and beginning on the south island.
10/31/85 Personal Photo TT

In May DU approved the project and in June DU decided to fund the construction for 1985. During the months of July and August refuge personnel along with DU engineers and biologists designed the project. An 8100 foot dike and two water control structures would subdivide Unit IV creating a new 393 acre impoundment. Two 2 acre islands would be constructed in the middle of this unit. Fifty-one hundred feet of level ditching would connect the borrowings of the dike and islands. A third 2 acre island would be constructed in Unit III. All three islands and the impoundment facing side of the dike would be rip rapped. The refuge would plant the islands and the dike to develop waterfowl nesting cover.

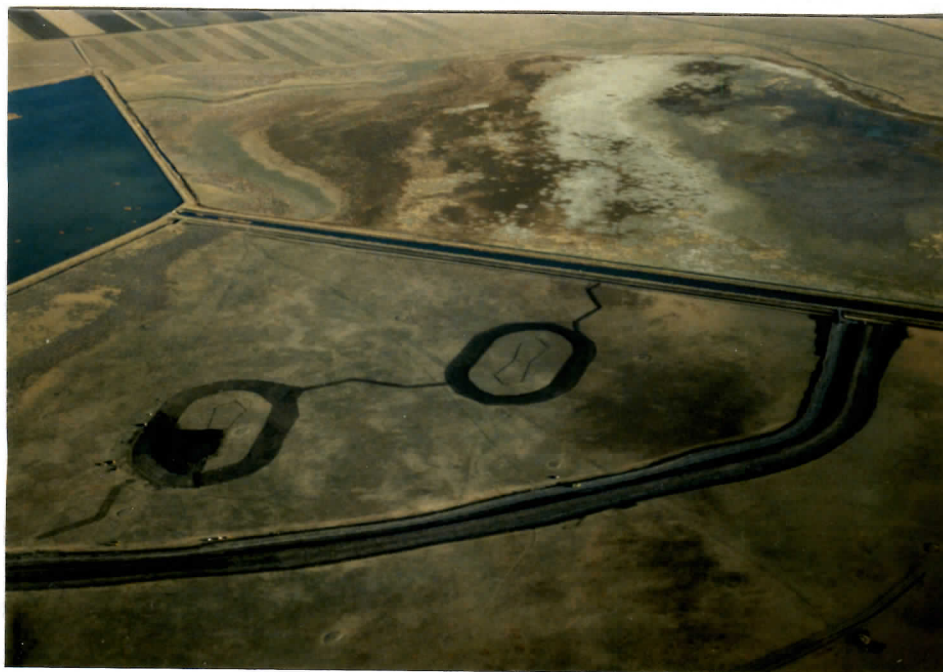
DU project construction layout showing hourglass island shape, wide bench and surrounding moats with inter-connecting angled canal system tying into the perimeter dike borrow areas which also form a surrounding moat even at low water levels.
10/31/85 Personal Photo TT

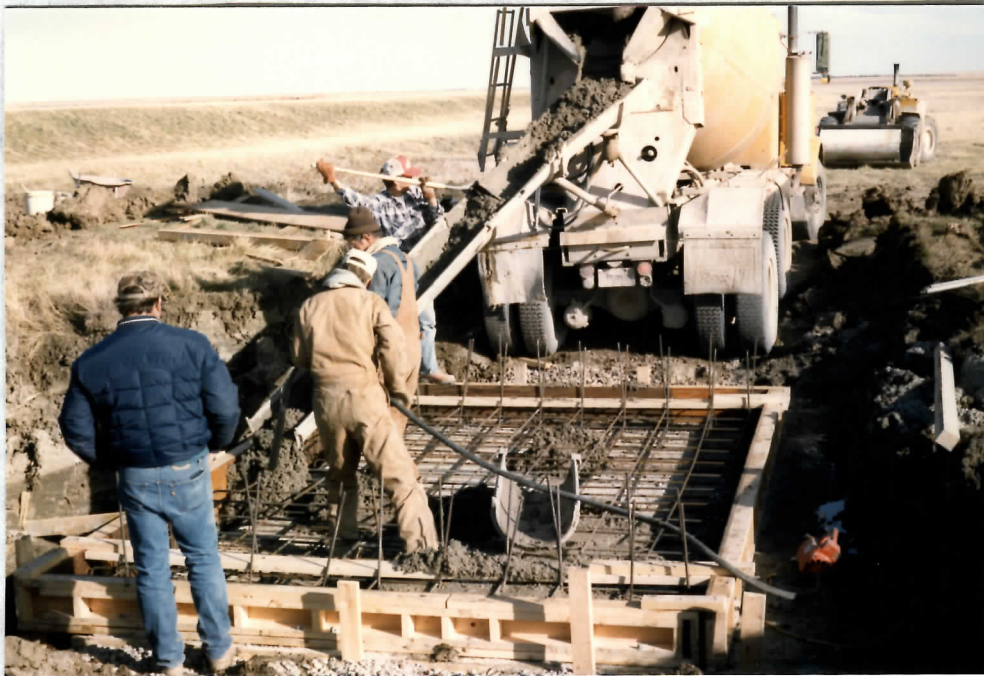
Brad Karel, Ducks Unlimited, (Bismarck office) inspecting first concrete delivery and placement into the base pad on the Unit IVb outlet water control structure.

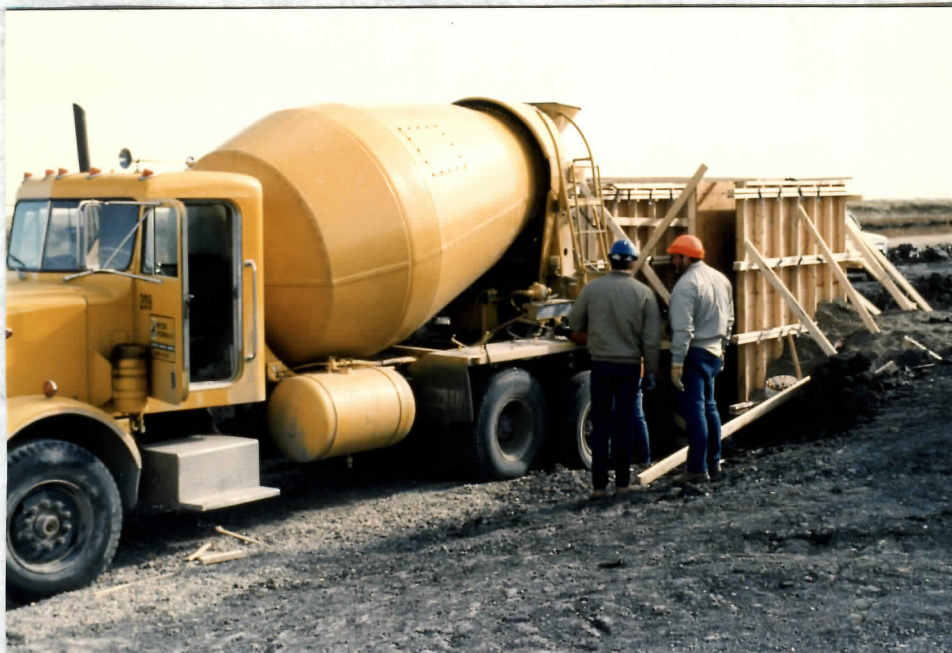
Karel conferring with the driver while the contractor, United Materials of Great Falls, is placing concrete into the 9'4" tall outlet control structure on IVb.

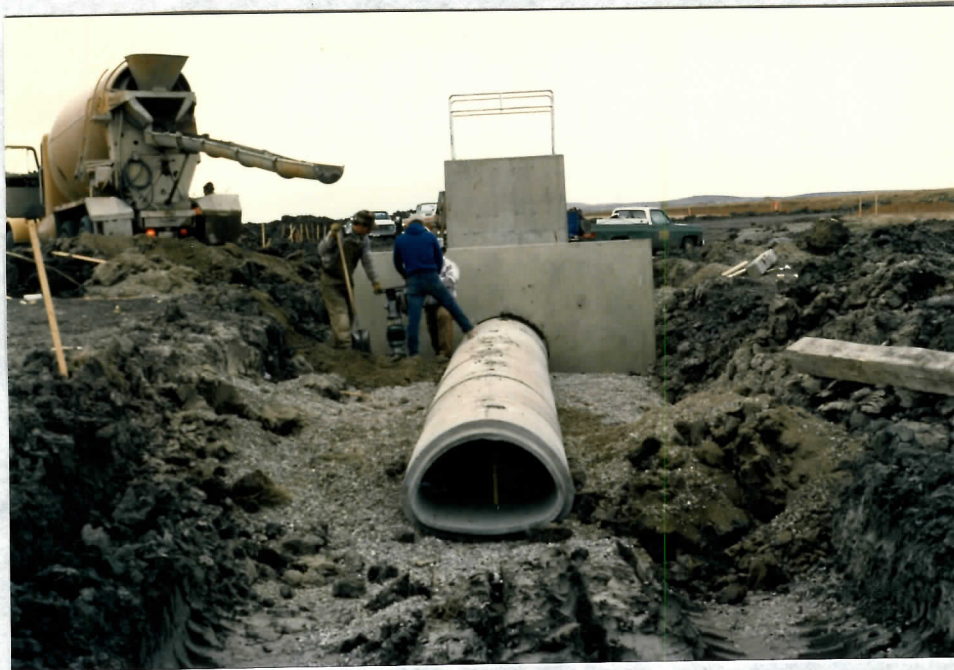
The 4 inch wide seep collar was prefabricated off site, then hauled in and assembled with the 36" x 22" arch pipe. The bedding gravel shown here proved to be a problem with the structures leaking. The contractor had to excavate and redo two of the joint seals and recompact the dike fill over this structure.

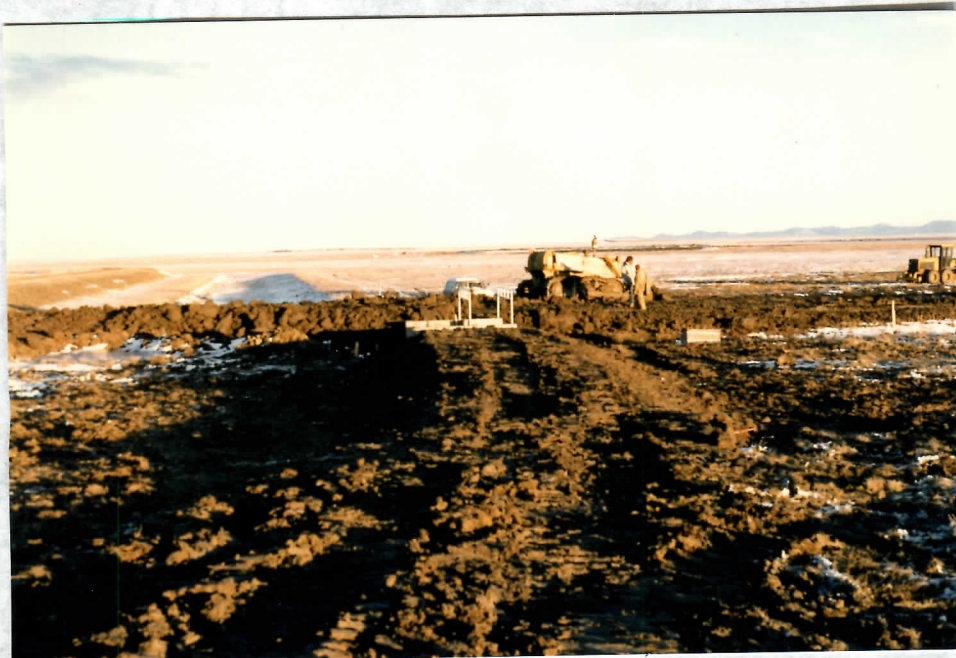
Final fill and compaction work on the inlet structure near the west end of the 8100 foot IVb dike, as viewed from the end of the stub dike. Highwood Mountains in the background.

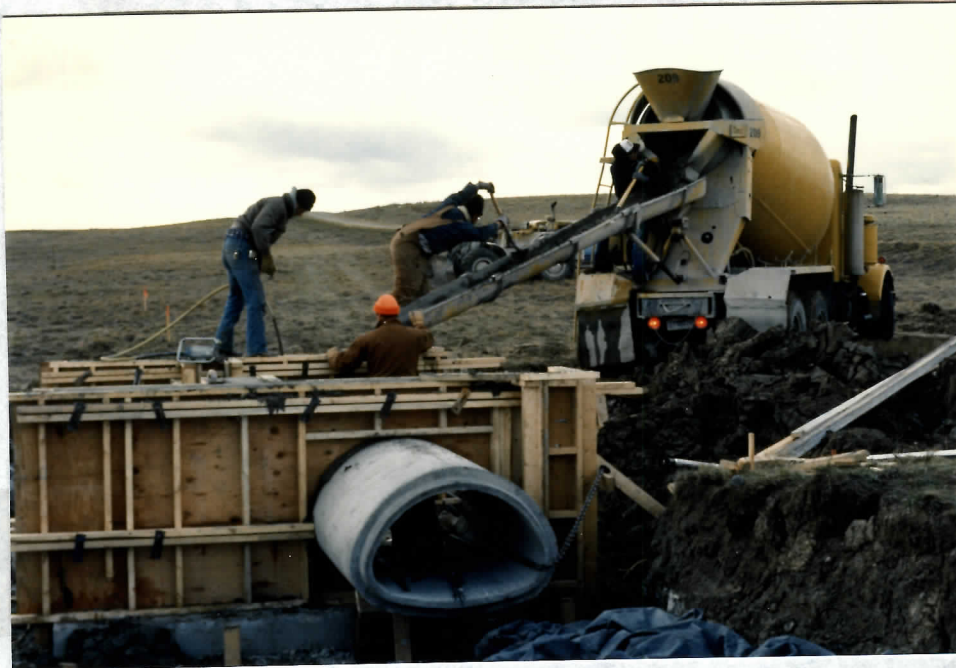
Concrete being placed in the forms on the IVb inlet structure.
An extra thick base pad was placed under this structure due to
an excess subsurface moisture problem,
11/05/85 85-19-25 TT

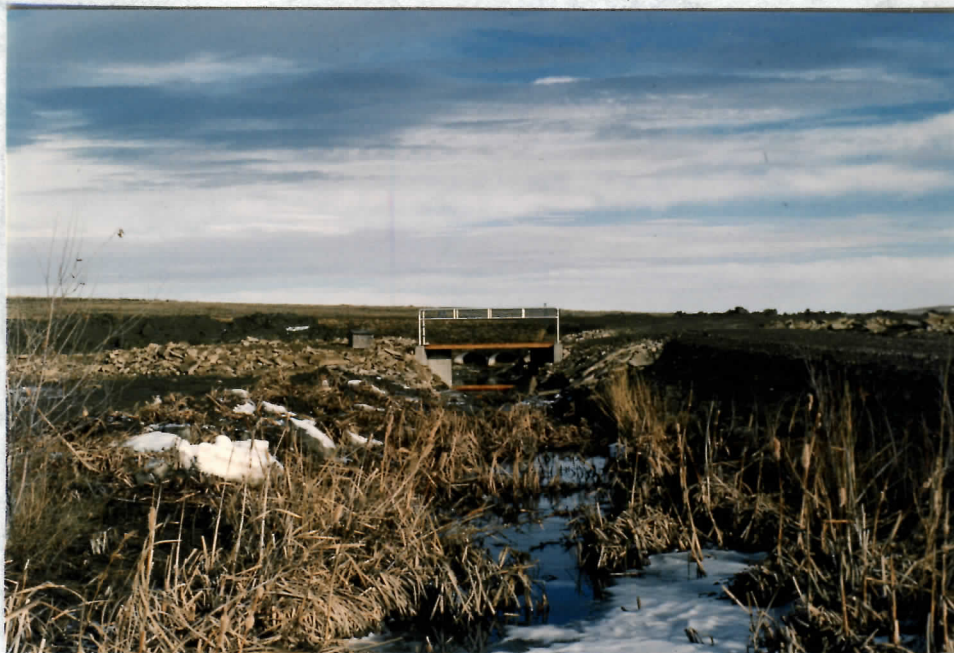
The completed IVb inlet structure as seen from the IVa canal.
Note the twin metal arch pipes which release water from Unit
II. This water can then be either diverted into IVb, or IVa,
or both simultaneously.
01/31/86 86-2-9 RLP

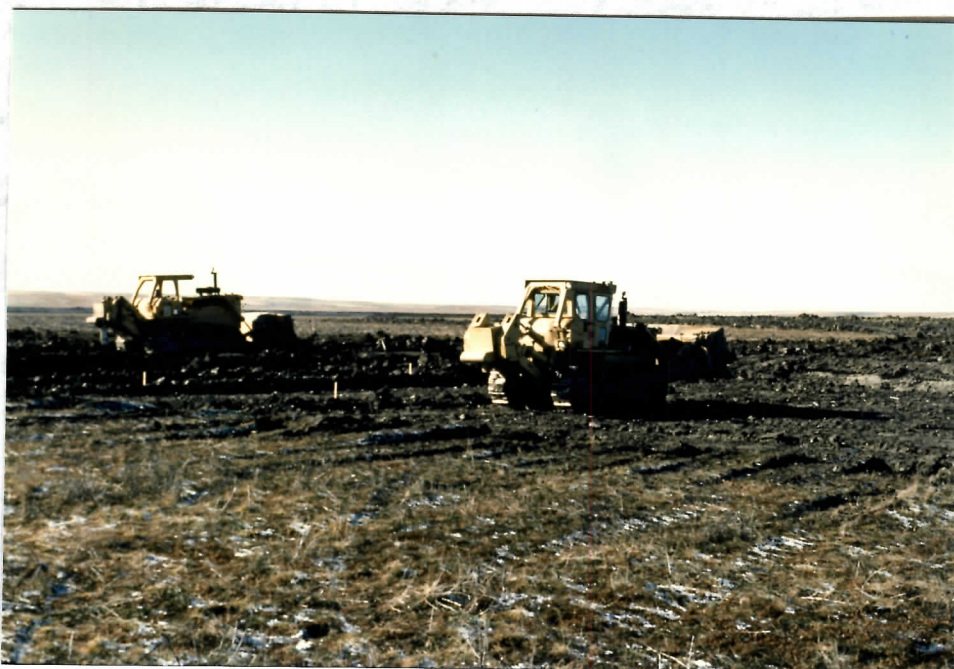
We anticipated that the dirt part of this contract would be undertaken primarily with the use of scrapers. This D8 and D9 were the main movers, with a D6 doing finish grading and a sheepsfoot roller compactor solidifying the pushed up fill.

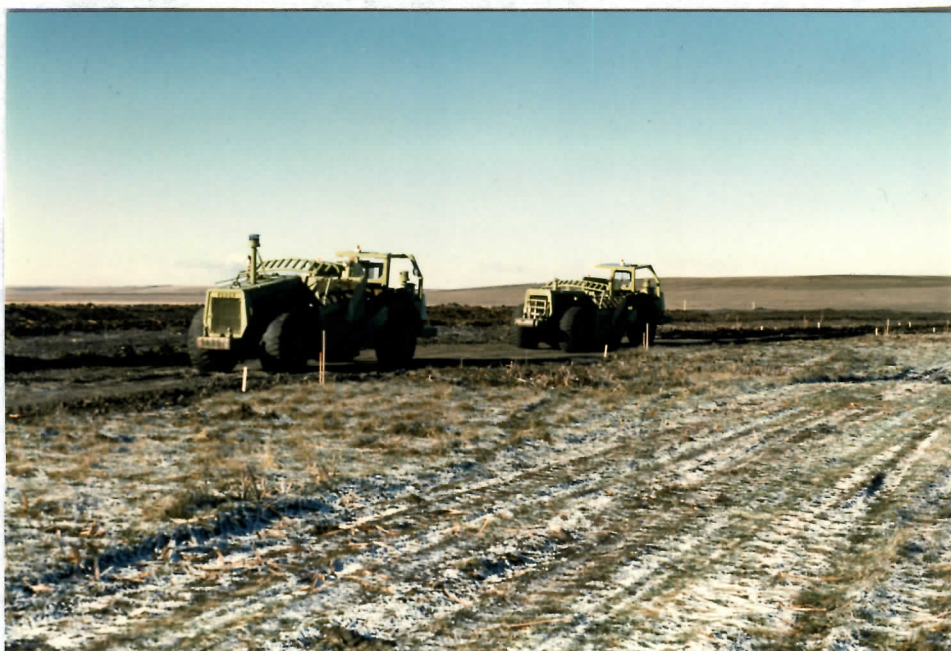
Two scrapers were brought in briefly to solve a problem of excess fill at the tailend of the dike. The materials were originally supposed to be incorporated into the dike - a communication problem - readily resolved by DU. Gee! It was fun working with DU and a quality contractor!

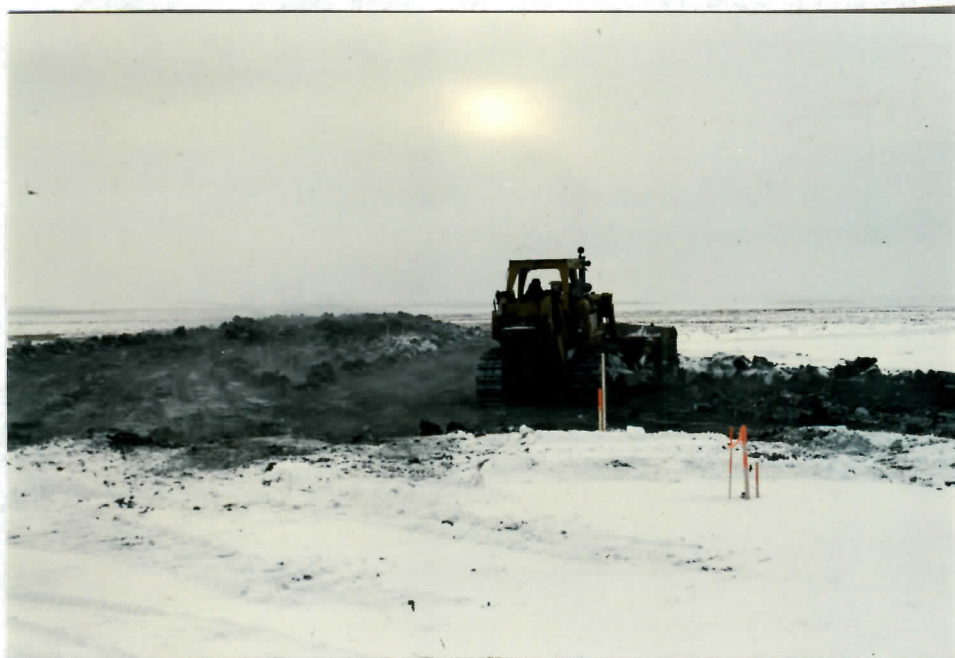
On this cold day the Cats moved into Unit III and in "sunny" midafternoon began opening the warm frozen earth to let out the steam. Soil moisture conditions were so moist that without the cold temperatures, this island probably wouldn't have been built.
11/21/85 85-21-21 TT

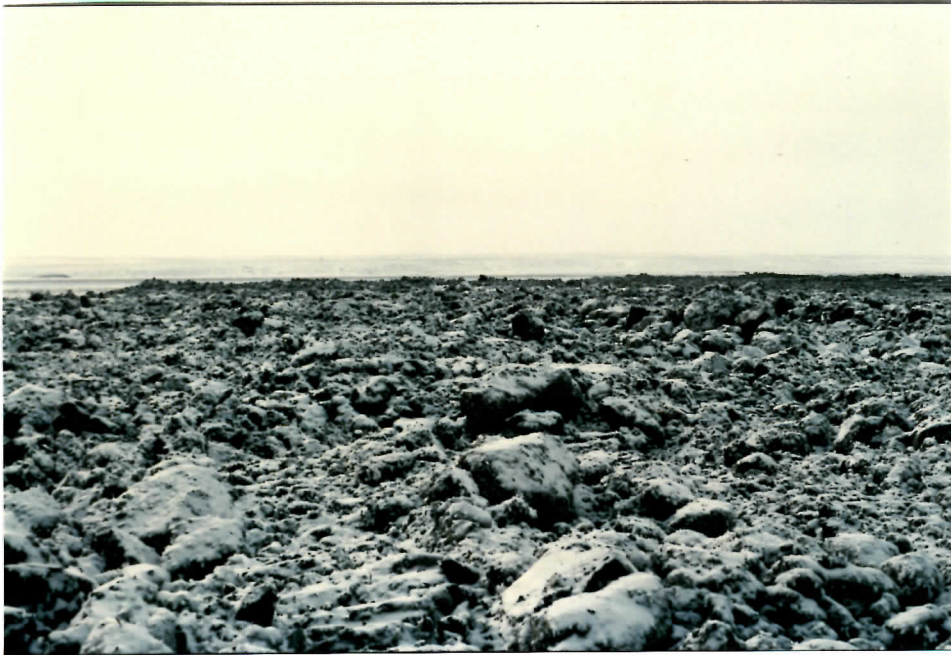
Working frozen marsh bottom soils at 20 below wasn't as difficult as we imagined. A D9 with a single chisel point breaks through one foot of frozen soil easily - - but how do you drill seed into that surface? The south island covered 3.26 acres.

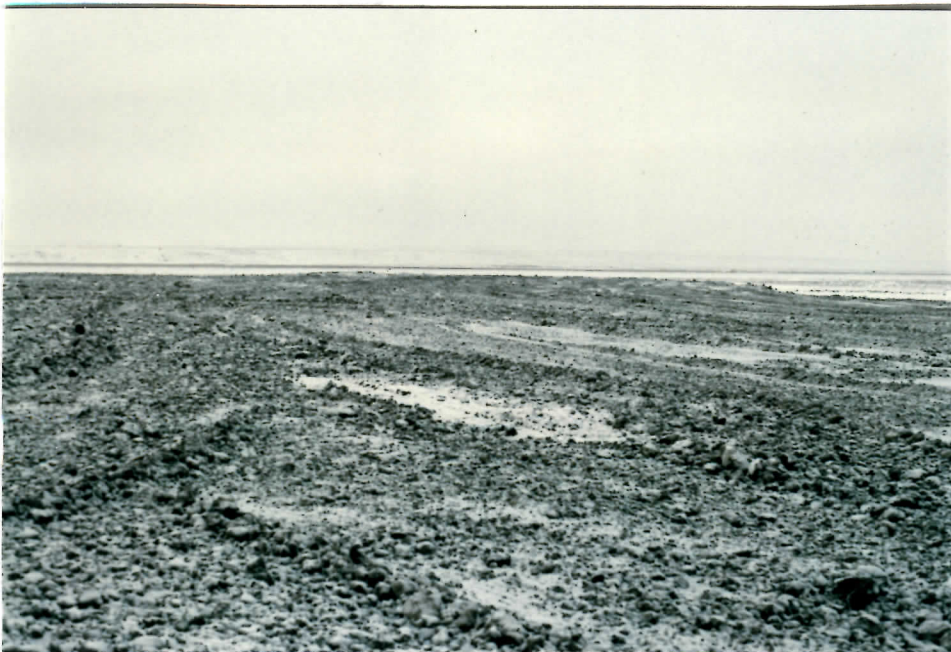
These "boulder field" islands were walked down using the D9, thus making the tops of the islands easily plantable using the refuge drill. The frost action on the heavy clays in any remaining dirt boulders crystalized them and they would then quickly crumble with a kick of the boot.

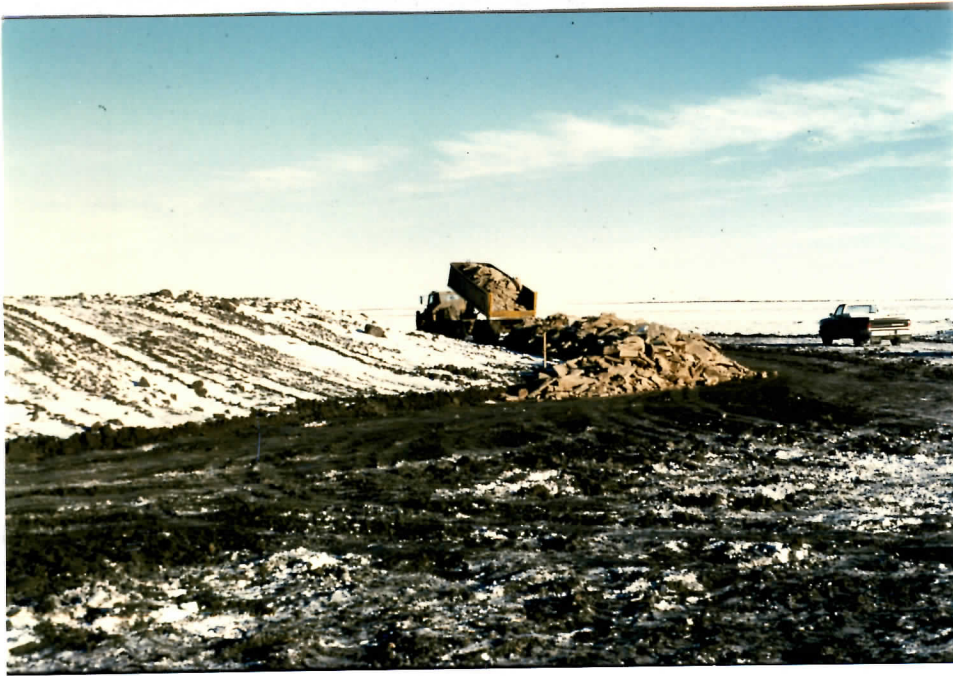
Delivery of sandstone rip rap began with a total of 1,596 cubic yards placed on the slopes of the three islands and on slopes of the new dike (\$17.50/yard in place).

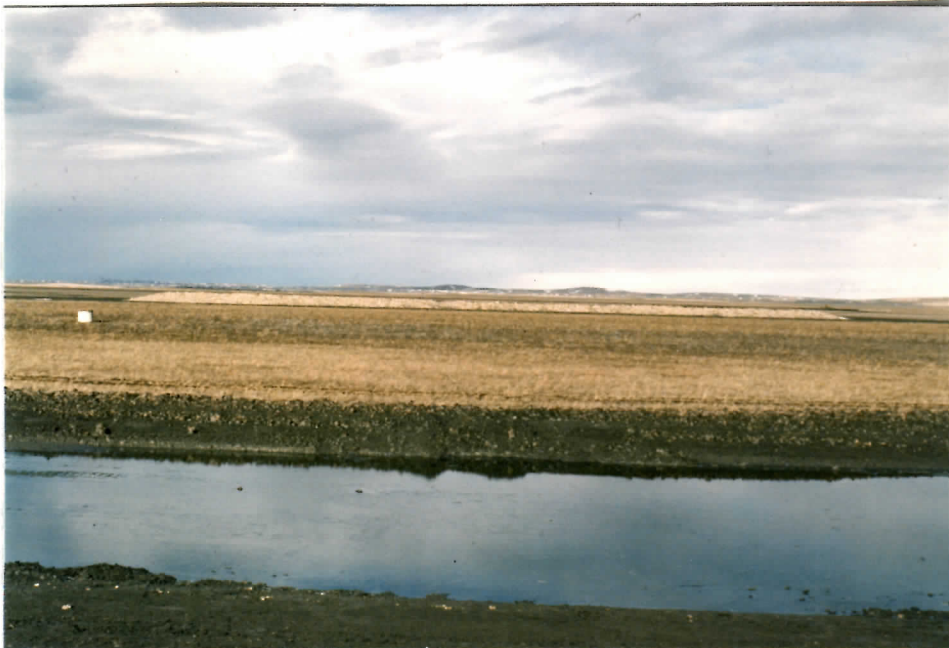
The northern most island, completely encircled with sandstone slab rip rap, encompasses 1.8 acres and is six to seven feet high.

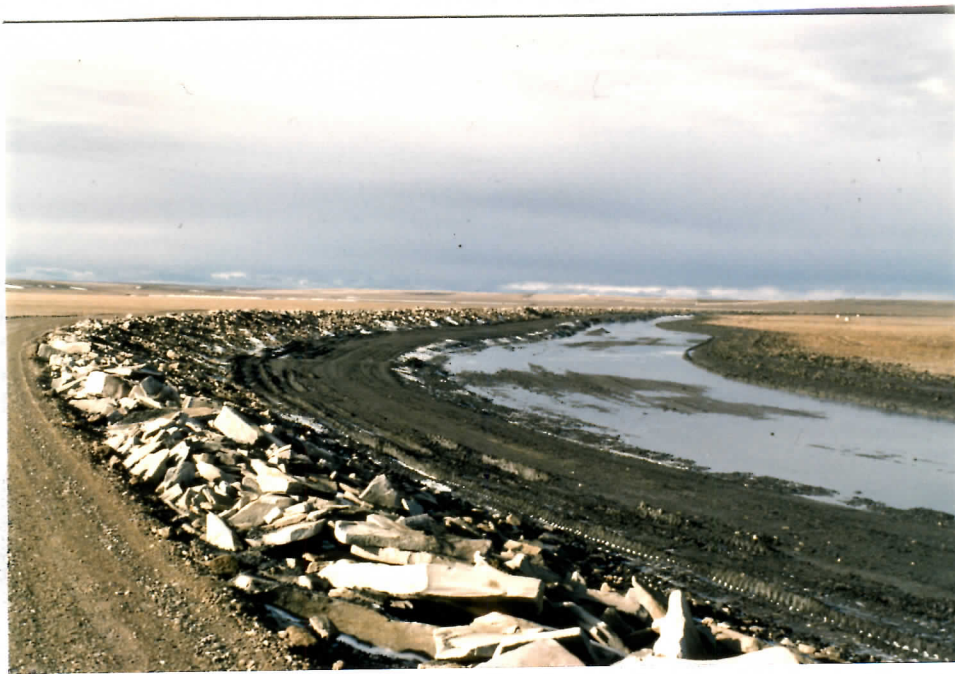
Completed dike IVb showing sandstone rip rap on inside
(3:1) slope of dike.
01/31/86 86-2-30 RLP

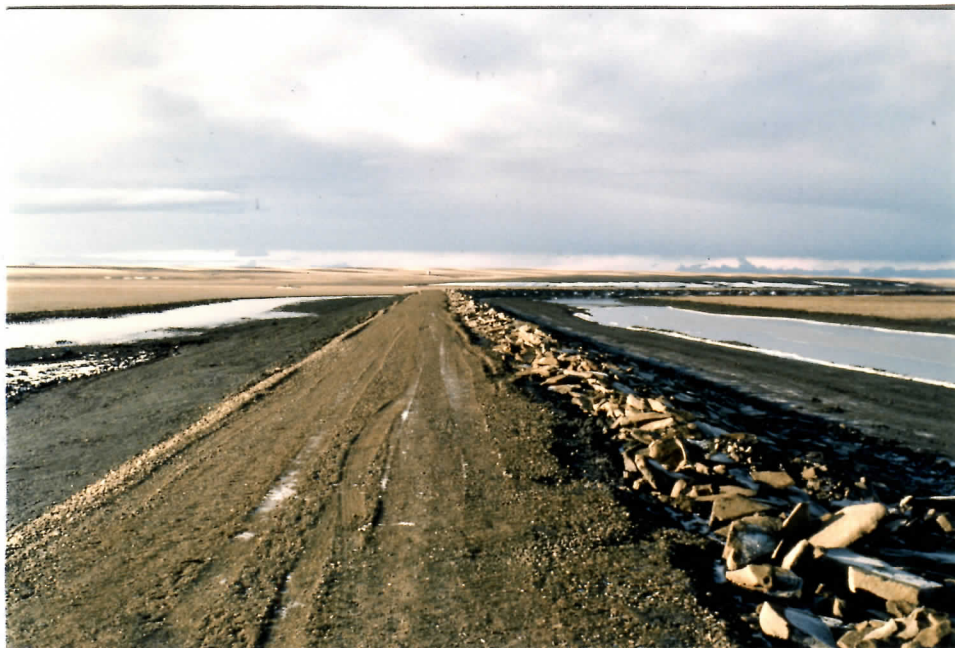
Unit IVb dike with gravelled top and unprotected outer 5:1
slope which will be planted to a grass mixture. Borrow areas
partially filled at the 3612.8 elevation.
01/30/86 86-2-1 RLP

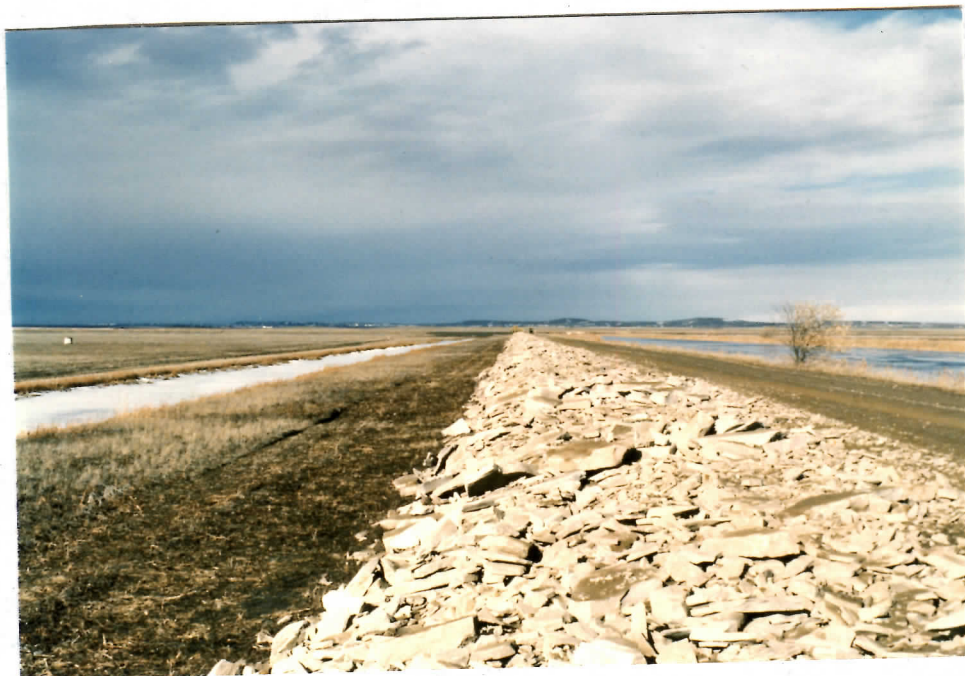
Erosion protection on the upper segment of the old Unit IV dike was beefed up with this added layer of sandstone rip rap as part of the Unit IVb DU project.

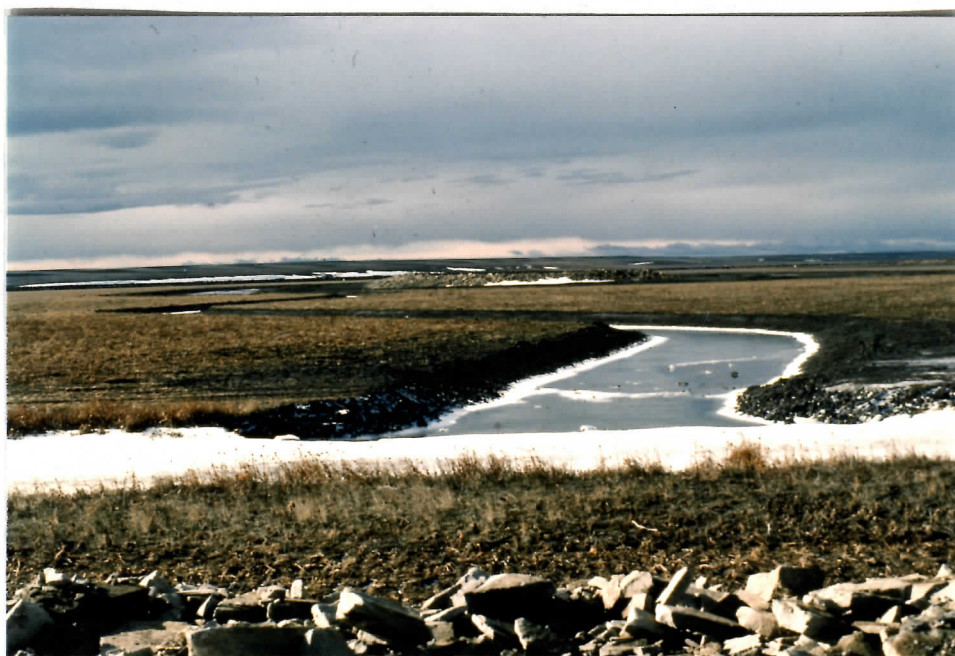
The connecting level ditches between the islands and the dike borrow ditches were angled at every 125 feet to increase their biological potential for duck breeding pairs.

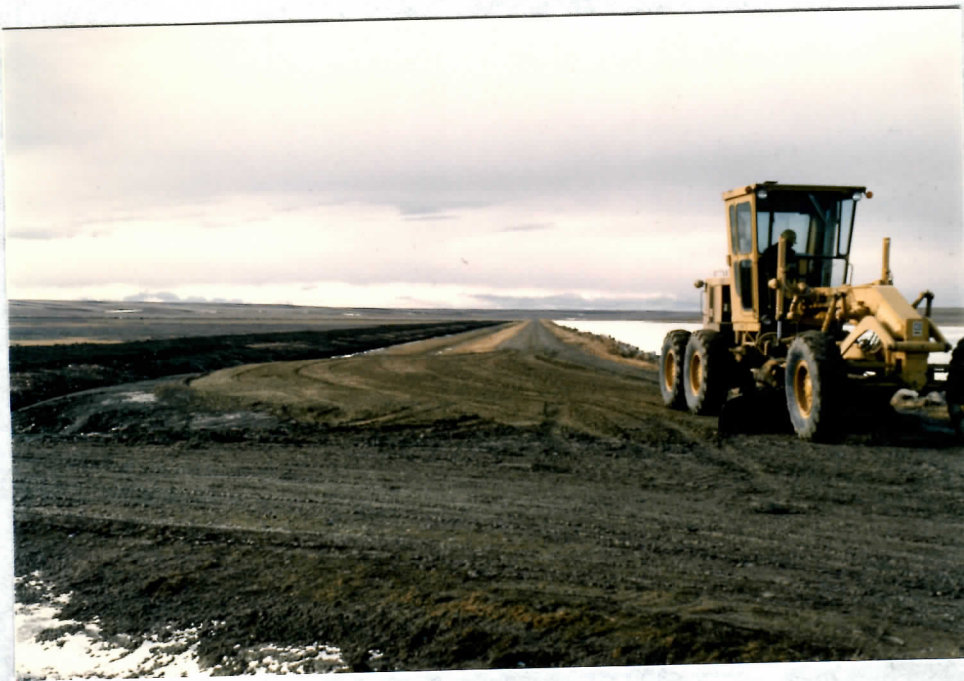
Some 2736 tons of crushed road gravel were delivered and placed by the DU contractor, including this new parking lot at the junction of the II and IV dikes. Dark soil on the left is from cleanout operations on the II dike borrow area facilitating a continuous moat and brood travel lane around the unit.

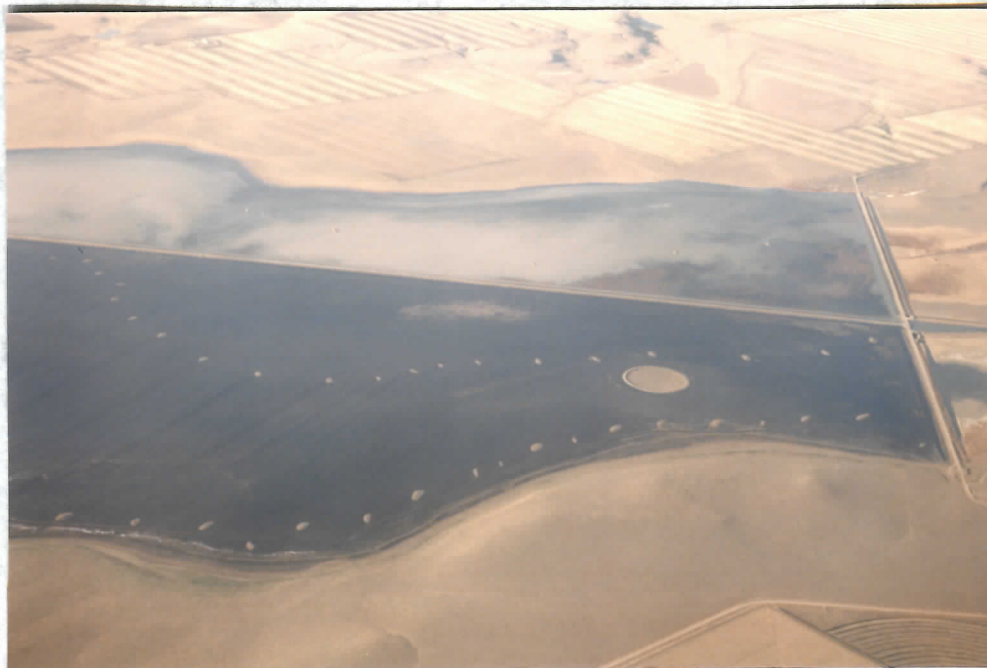
Unit V was dewatered in 1983 and 1984 and a perimeter and interior canal system excavated to facilitate positive drainage into the pumpsites. Excavated materials were used to construct 66 low profile loafing islands, 2 peninsulacutoffs and one 4 acre circle dike. Water shortages (pumping \$) delayed refilling the unit until the fall of 1985.

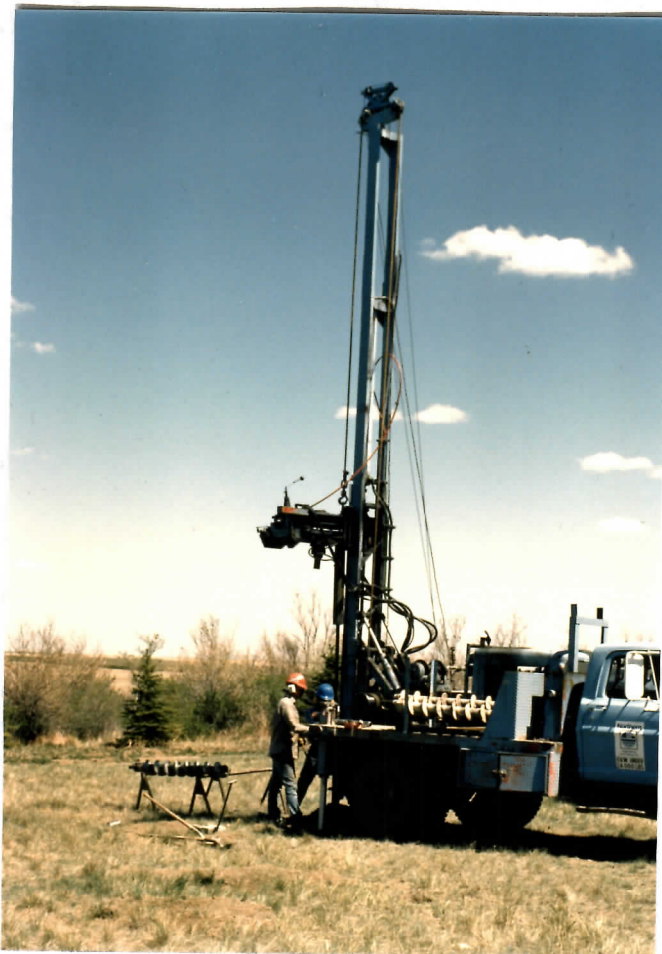
Equipment storage building contract. Northern Testing conducting soil tests to provide foundation design recommendations for the new 40 x 155 foot storage building.
05/15/85 85-6-38 RLP

In August Talcott Building Company of Great Falls submitted a bid of \$72,621.00 for a 40 foot by 155 foot metal storage building. The building will be used for cold storage and a carpentry shop. Four bays have overhead doors and two bays are open. The south bay is 40 feet by 40 feet with a concrete floor. All other bays have gravel for flooring. By year's end the building was finished except for concrete aprons and drain spout splash blocks. One problem was noticed in the design of the overhead doors - they are inset and when closed rest on the gravel rather than on a concrete sill. Corrective measures will be taken to fix this. Other adjustments made included placement of tar and felt paper around the foundation which was purchased and installed by refuge personnel.

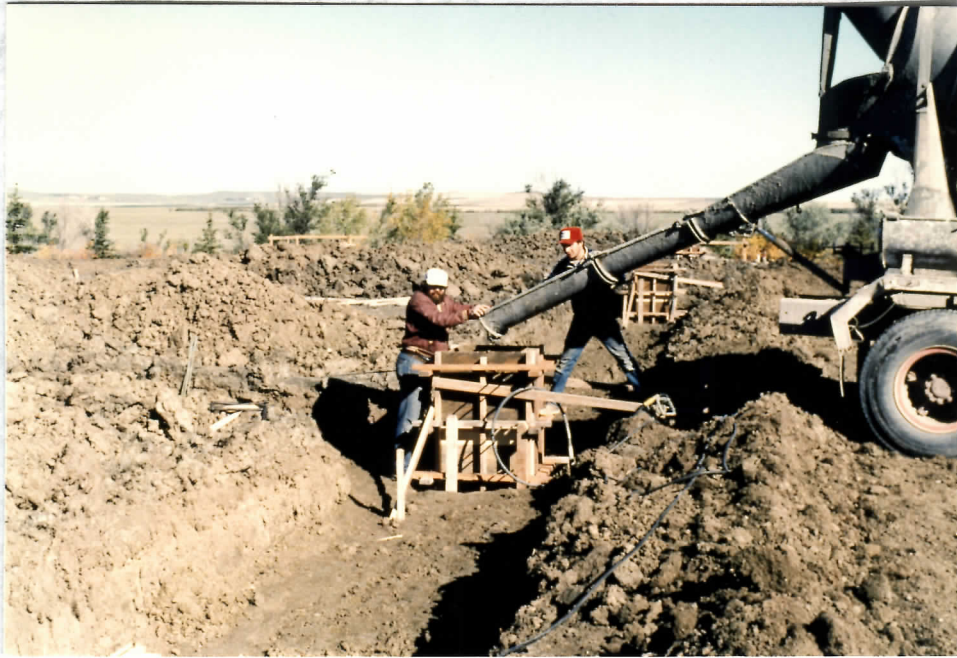
Talcott Construction crew placing concrete pillars to support the main structure. We found their concrete work to be almost flawless and their people easy to work with on needed clarification and changes as the project went along,
09/25/85 85-12-8 RLP

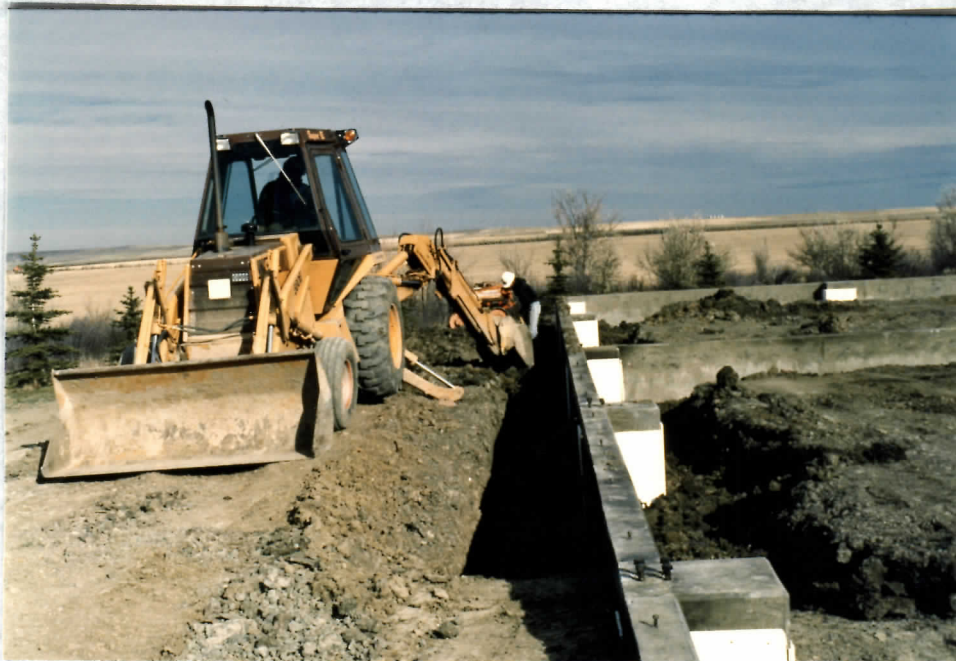
Columns and grade beams in place and finished, then bead board placed on the columns to provide a bond breaker. The refuge added 15 lb. felt paper along the outside of the grade beam. This is to reduce foundation movements caused by the pressures from the very expansive clay soils with moisture and temperature changes. Backfill and compaction was done by subcontractor.
10/30/85 85-14-9 RLP
